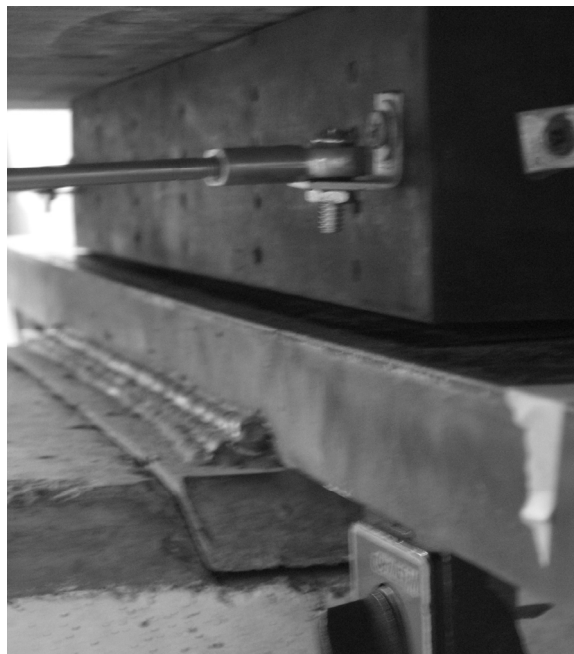
Figure 68. Pullout of embedded plate in girder
